# VEHICLE INSPECTION REPORT

**PE63MZY**

## Daf LF 45.140

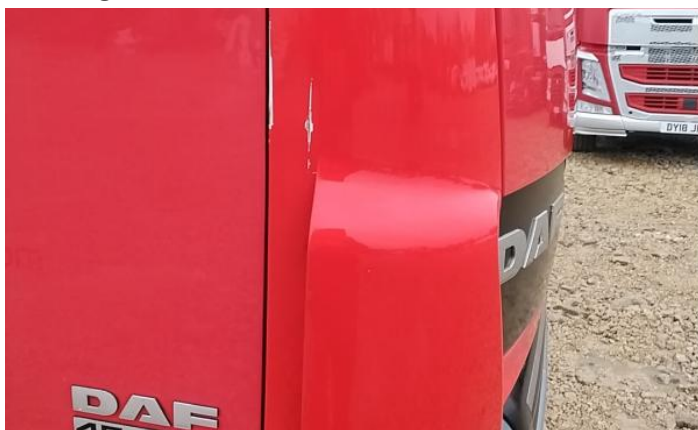
1: Wing of  
Cracked  
Replace

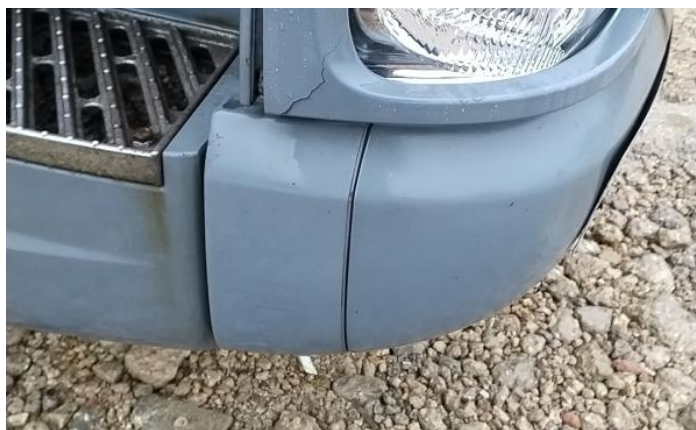
2: Fog Lamp Surround of  
Broken  
Replace

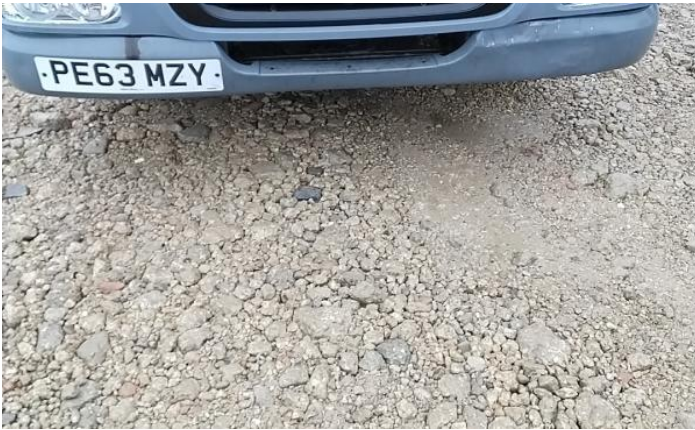
3: Bumper Front  
Dented  
With Paint Damage

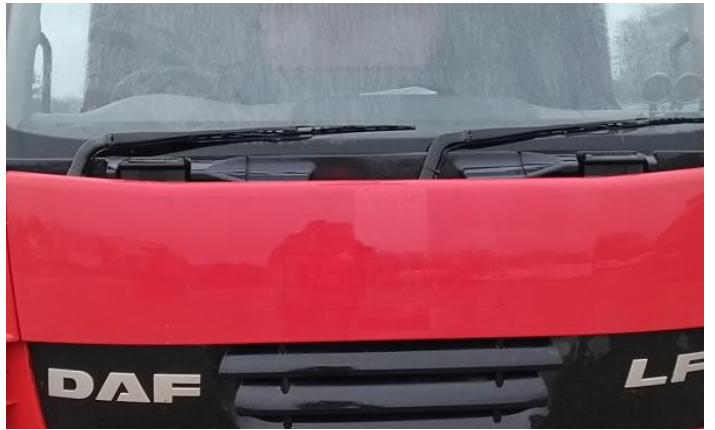
4: Screen Front  
Chipped  
Over 10mm

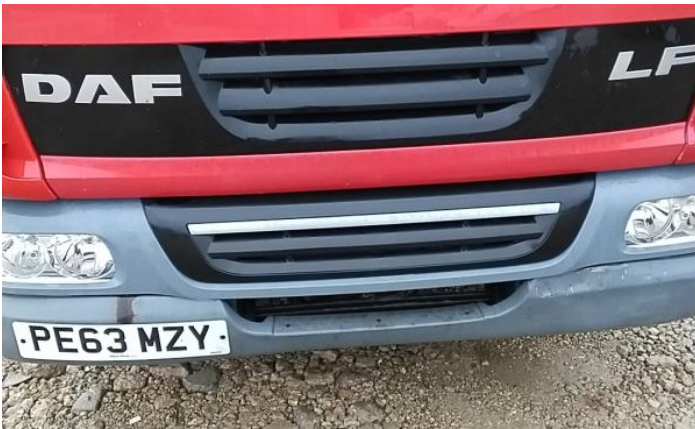
5: Bonnet  
Chipped  
Multiple Chips

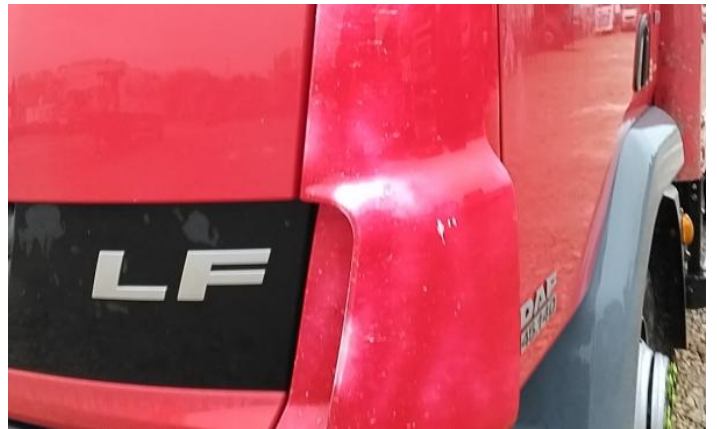
6: Wing nsf  
Poor Previous Repair  
Poor Paint

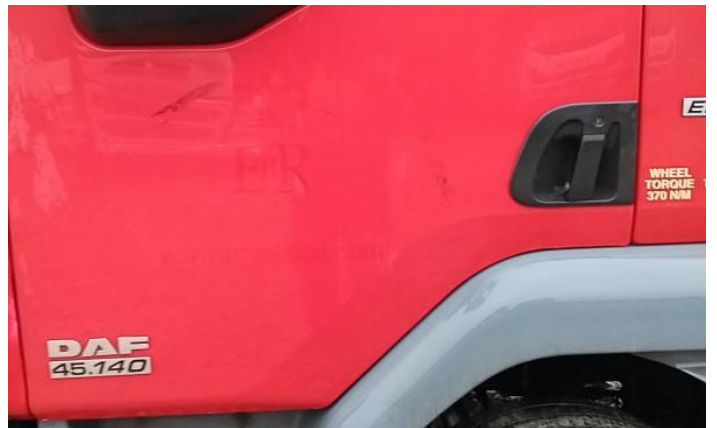
8: Door nsf  
Scratched  
Over 25mm Not Thru Paint

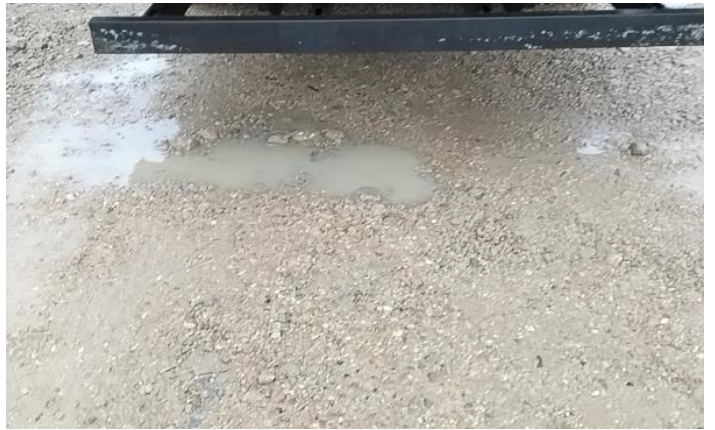
10: Bumper Rear  
Scratched  
Over 100mm Thru Paint

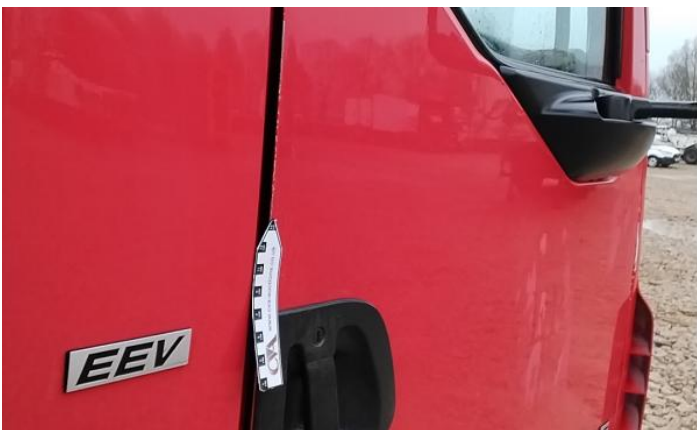
13: Door osf  
Chipped  
Edge Chip

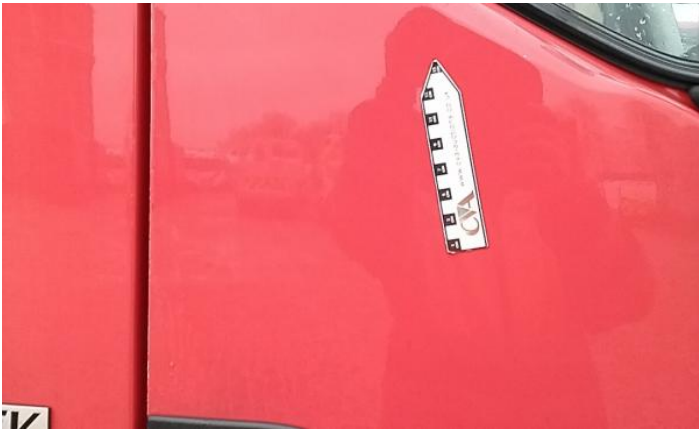
15: Door osf  
 Scratched  
 Over 25mm Not Thru Paint

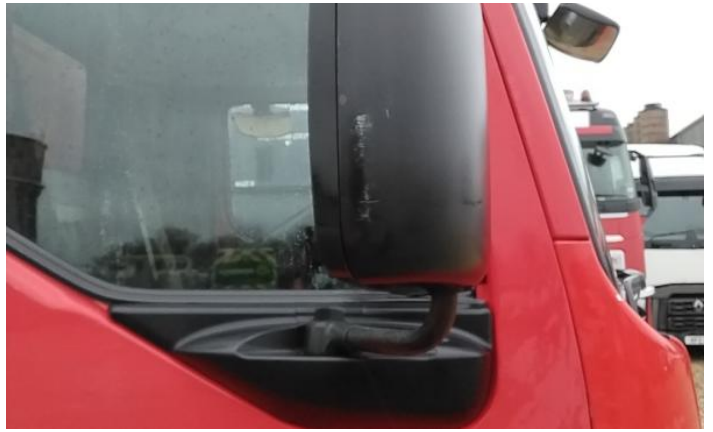
16: Door Mirror Assy osf  
 Scuffed (Unpainted)  
 Over 100mm
