VEHICLE INSPECTION REPORT

SV73KWH

Mercedes-Benz Sprinter 315 2.0 CDI PROGRESSIVE

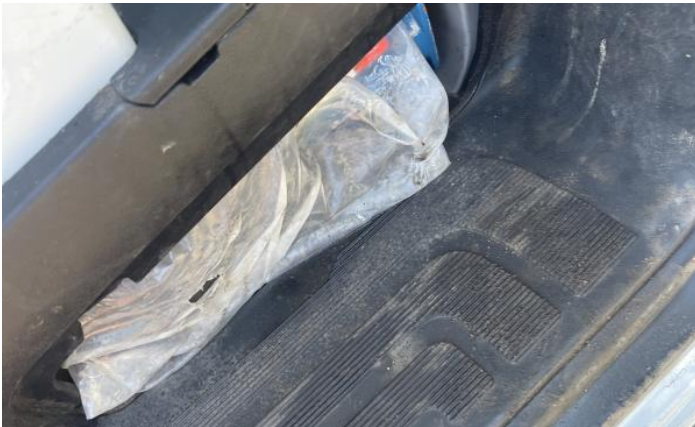
1: Seat Base Cover of
Missing
Replace

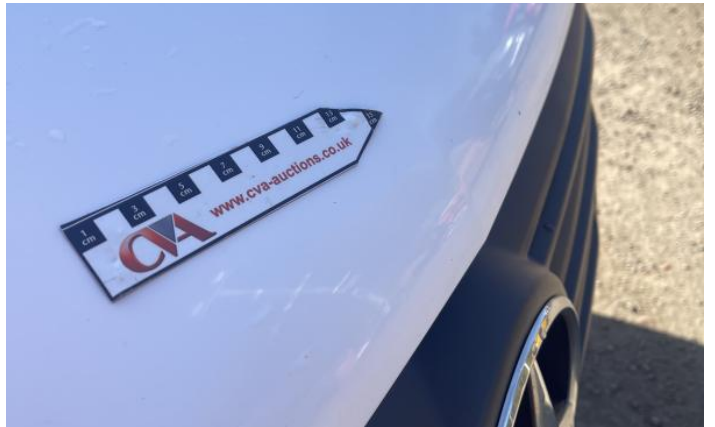
2: Bonnet
Dented
With Paint Damage

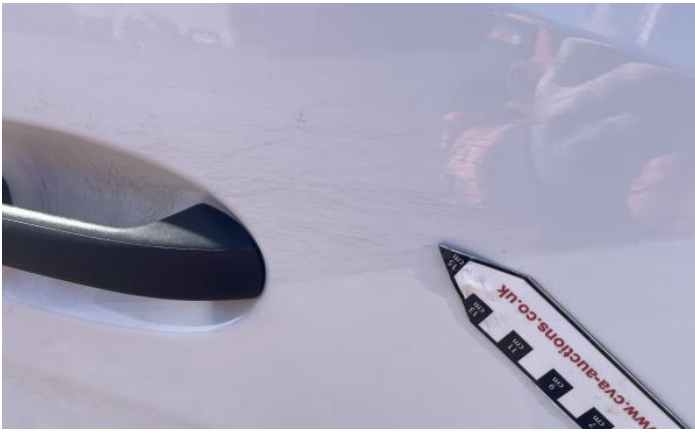
3: Door osf
Dented
Over 30mm

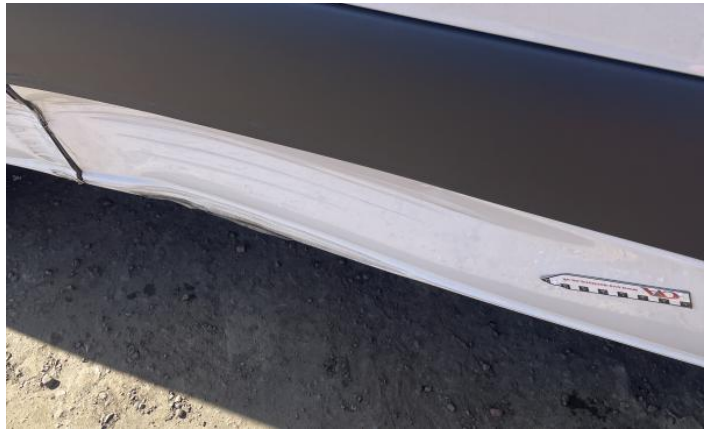
4: Qtr Panel osr
Dented
With Paint Damage

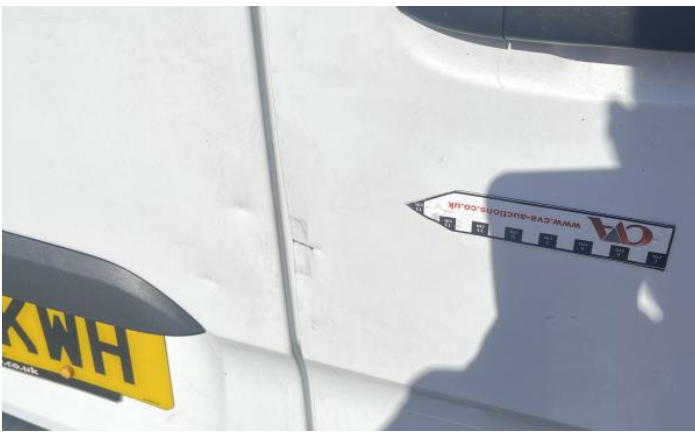
5: Tailgate
Dented
With Paint Damage

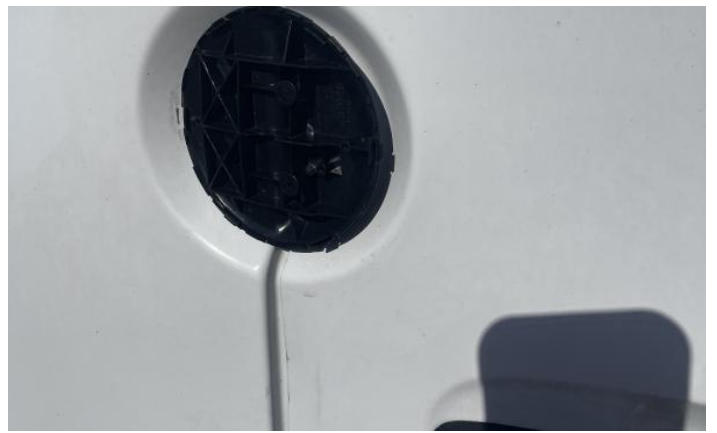
6: Badgedecal Rear
Missing
Replace

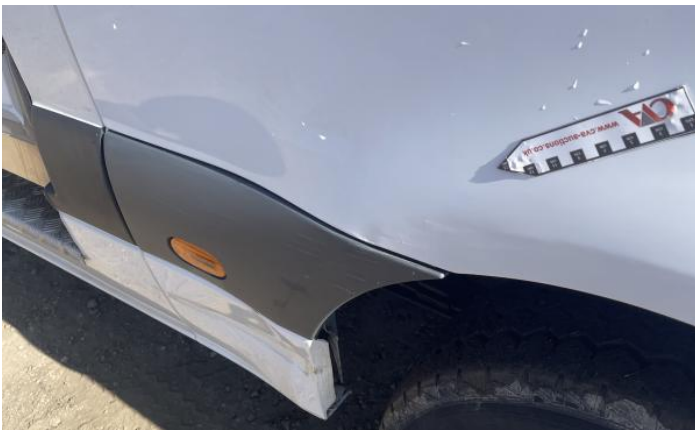
7: Qtr Panel nsr
Dented
With Paint Damage

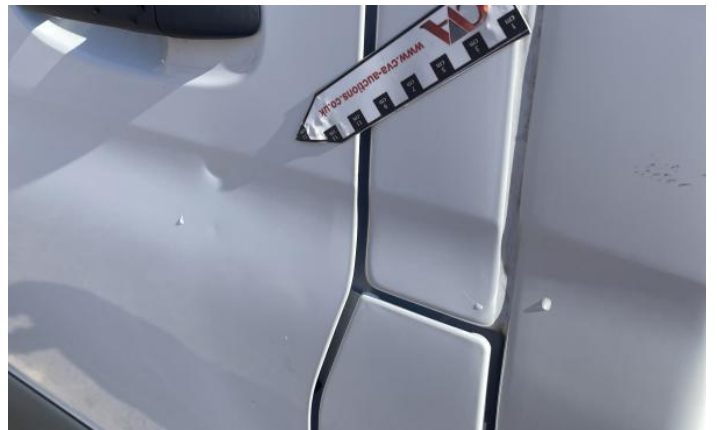
8: Door nsf
Dented
With Paint Damage
